## American Journal of Infection Control

## Major Article

# Splash generation and droplet dispersal in a well-designed, centralized high-level disinfection unit

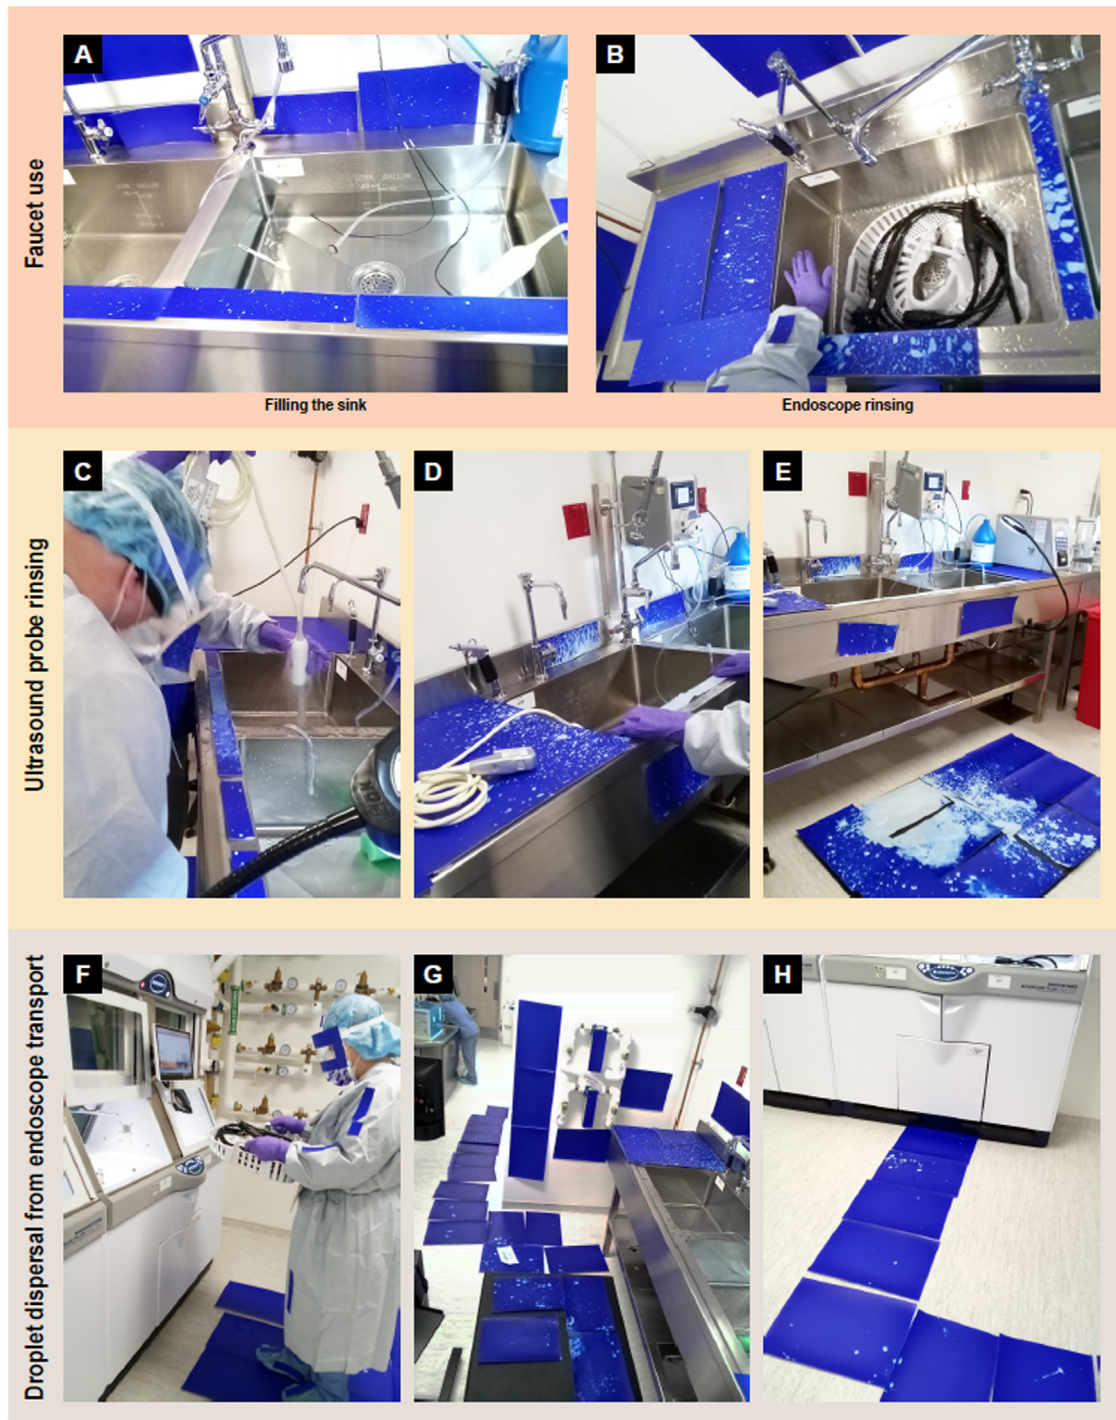
Fig 2. Workstation exposure to droplets during decontamination activities.

Splash was generated by almost every manual cleaning activity evaluated (Table 1). Activities that involved running the faucet were associated with the substantial splashing (Fig 2A-B). Rinsing the probe per IFU (two minutes under running water)<sup>9</sup> generated more small droplets, large droplets, and confluent puddles of water around the sink than any other activity (Fig 2C-E).

Droplets were detected on counters, walls, a wall-mounted water filtration system, an irrigation system, a magnifying glass, a leak tester, floors, and carts. Upon completing manual cleaning activities for the colonoscope and probe, multiple droplets were recorded between 4 and 6 feet (1.2-1.8 meters) from the decontamination sink. Droplets from rinsing the probe were observed on the floor 7.25 feet (2.2 meters) away. Transport of a wet endoscope and cassette between the sink and AER generated droplets that were visible on the entire path (>15 feet; 4.6 m) (Fig 2F-H).

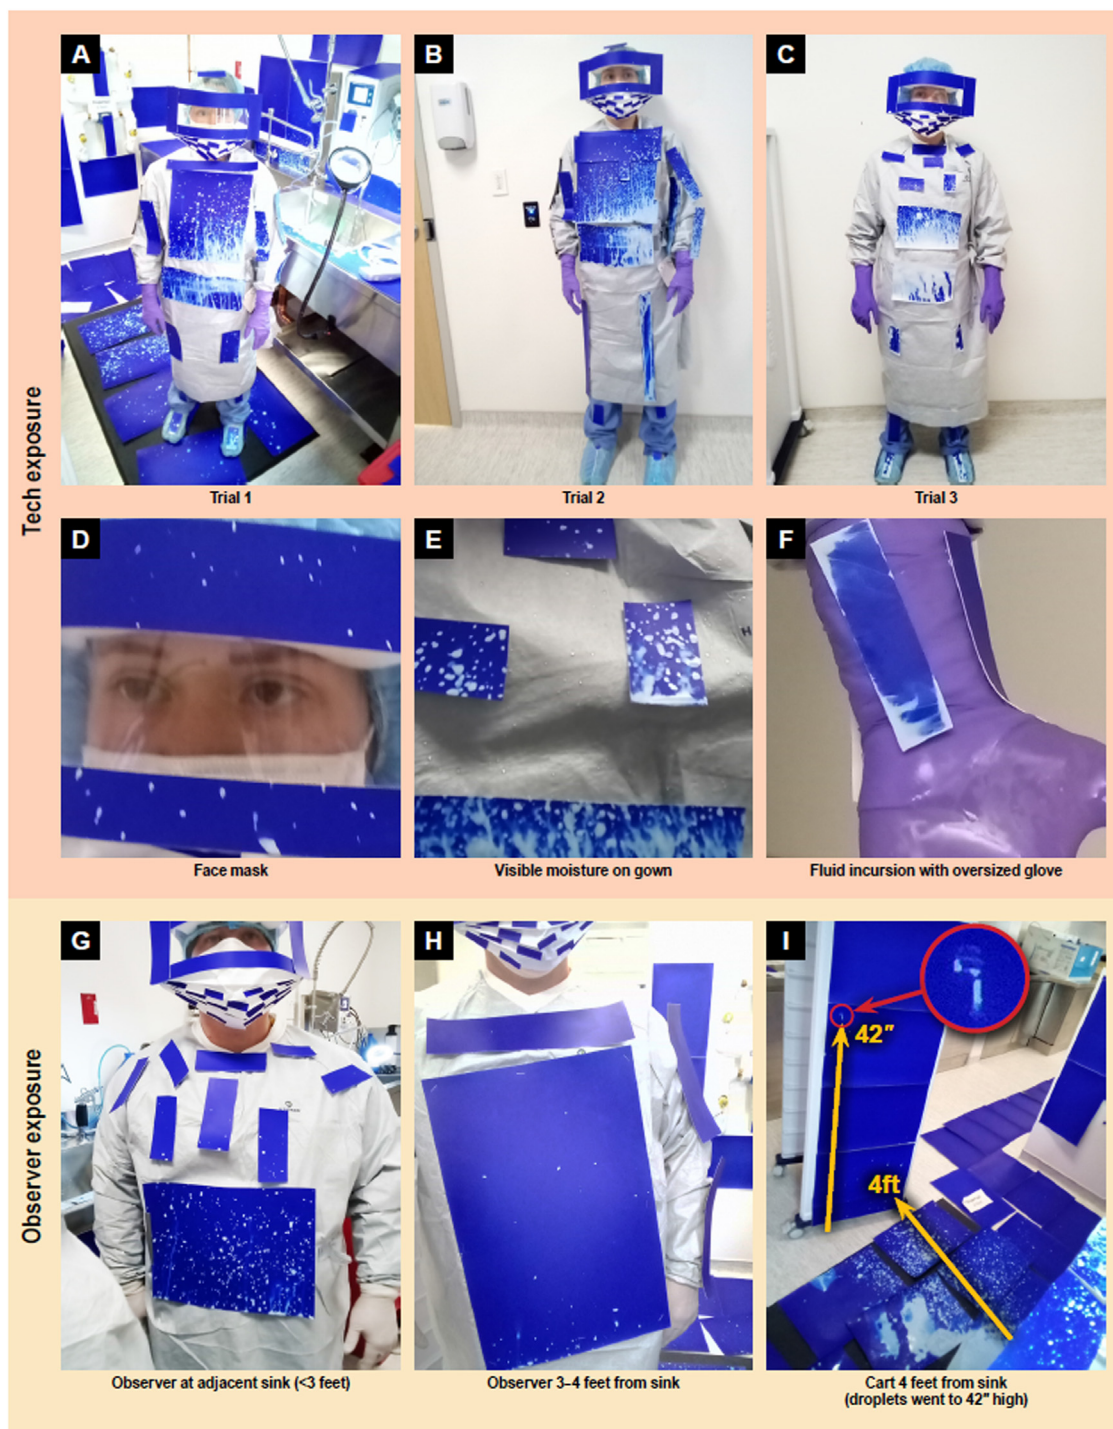
**Fig 3.** PPE exposure to droplets generated during probe decontamination activities.

The technician at the sink was exposed to droplets from head to toe during most activities (Table 1). During high-splash activities like probe rinsing, confluent splash patterns and droplets TNTC were observed on gowns and shoe covers (Fig 3A-C). Face shields and the extended chin cover were frequently exposed to substantial splash (Fig 3D). In some cases, large numbers of droplets were visible on the gown around the moisture-detection

paper that were not reflected in the droplet counts in Table 1 (Fig 3E). The technician noted that despite heavy splash exposure, the gown effectively repelled the moisture for the duration of the experiment (cleaning one device). No fluid incursion was observed when the technician wore properly sized gloves. Fluid incursion was observed on the interior glove when exterior gloves were too large (Fig 3F).

Extensive droplets were detected on gowns and shoe covers of observers at an adjacent sink (Fig 3G; Table 1). Observers standing 3 to 4 feet (0.9–1.2 meters) away were also exposed to

droplets (Fig 3H). More observer exposure occurred during the probe rinsing than other activities (Table 1). Numerous droplets were observed on a cart 4 feet (1.2 meters) away during probe rinsing, including several droplets at least 42 inches (1.1 meters) off the ground (Fig 3I). During brushing when the endoscope was incompletely submerged, an observer standing 3 feet (0.9 meters) away reported droplets spraying past their head, but no droplets were visible on the moisture-detection paper. Despite wearing a head cover, this observer also felt droplets on top of their head (i. e., skin exposure). A subsequent attempt to document droplet
